INADVERTENT SUBCLAVIAN ARTERY CANNULATION DURING CENTRAL VENOUS CATHETER PLACEMENT

– PULL OR REPAIR?

Carlos Veiga, Pedro Sá-Pinto, Sérgio Teixeira, Gabriela Teixeira, Inês Antunes, Daniel Mendes, Carlos Veterano, Carolina Vaz, Rui Almeida
Serviço de Angiologia e Cirurgia Vascular - Centro Hospitalar Universitário Porto – Hospital Geral de Santo António

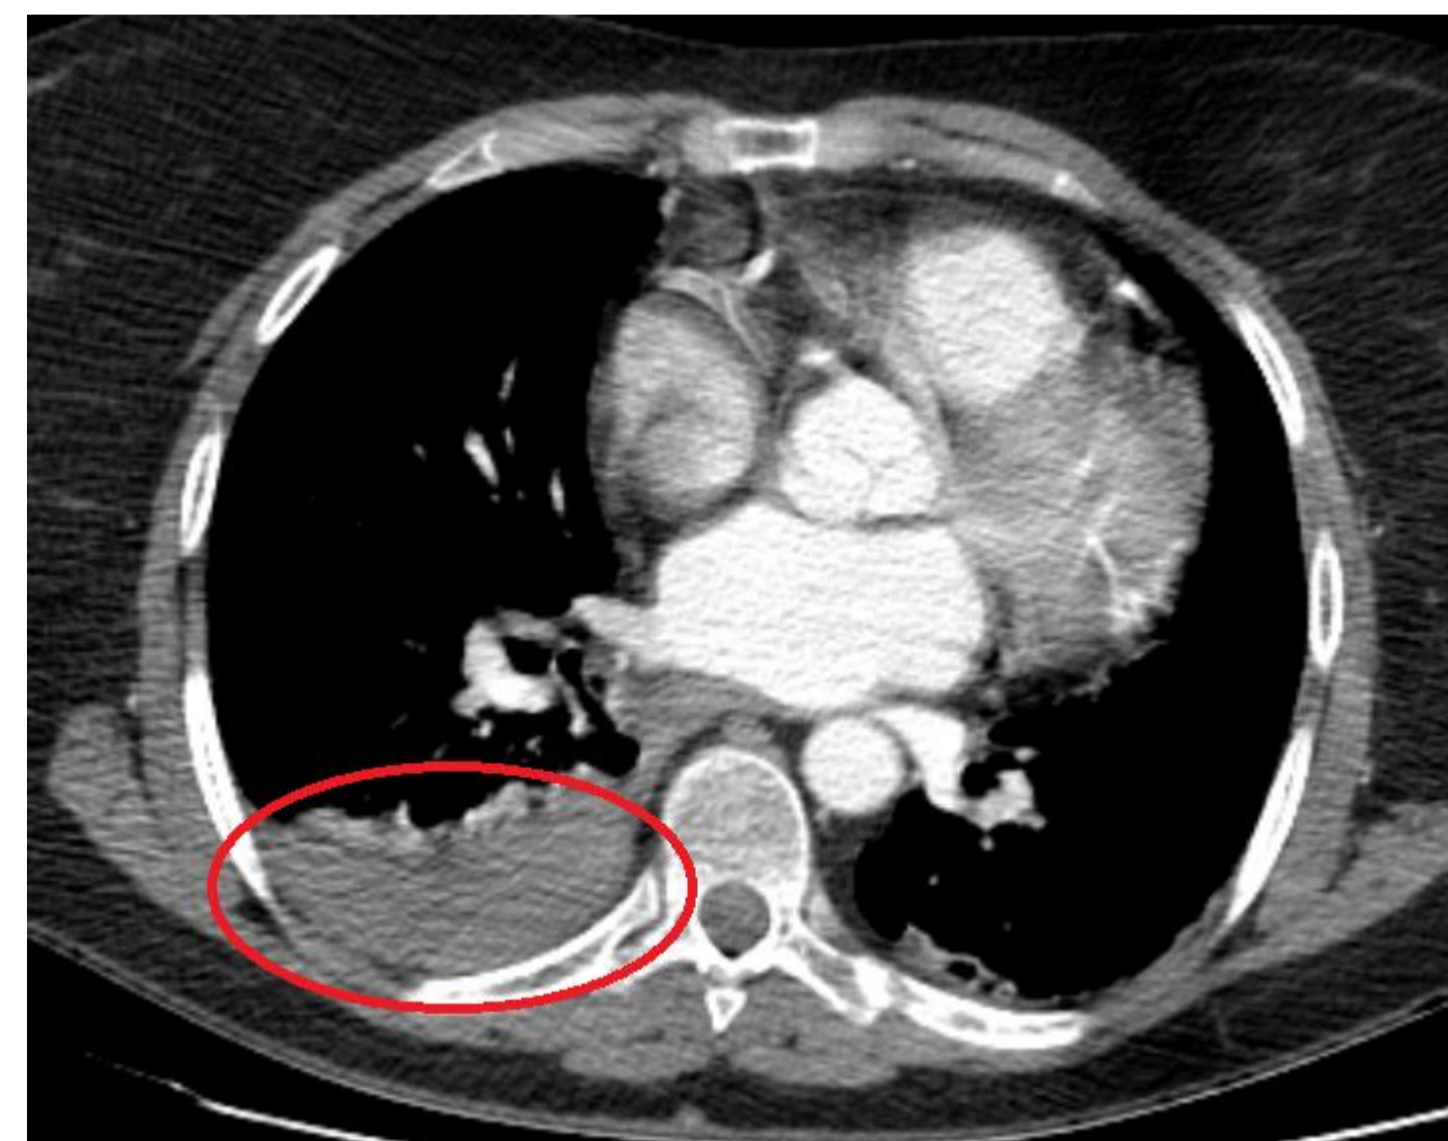
ANGIO-CT SCAN

RIGHT HEMOTHORAX

The patient was kept under surveillance and repeated CT Scan at 24h with no signs of progression. No other complications were reported.

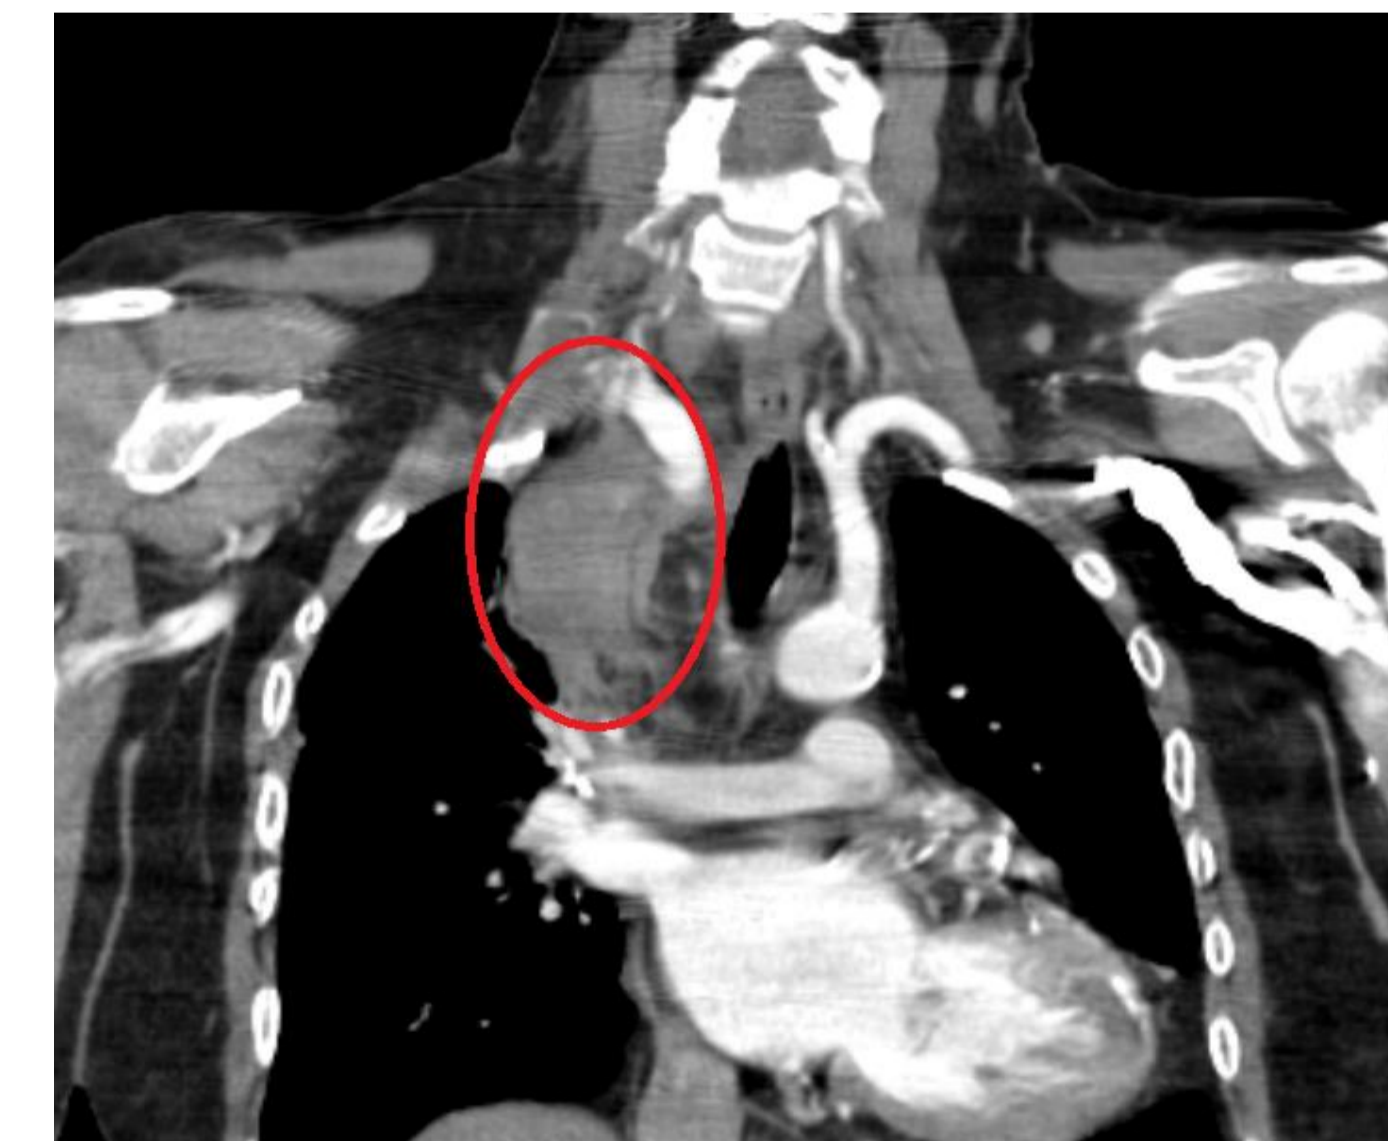
CERVICAL AND MEDIASTINAL HEMATOMA

NO SIGNS OF ACTIVE BLEEDING

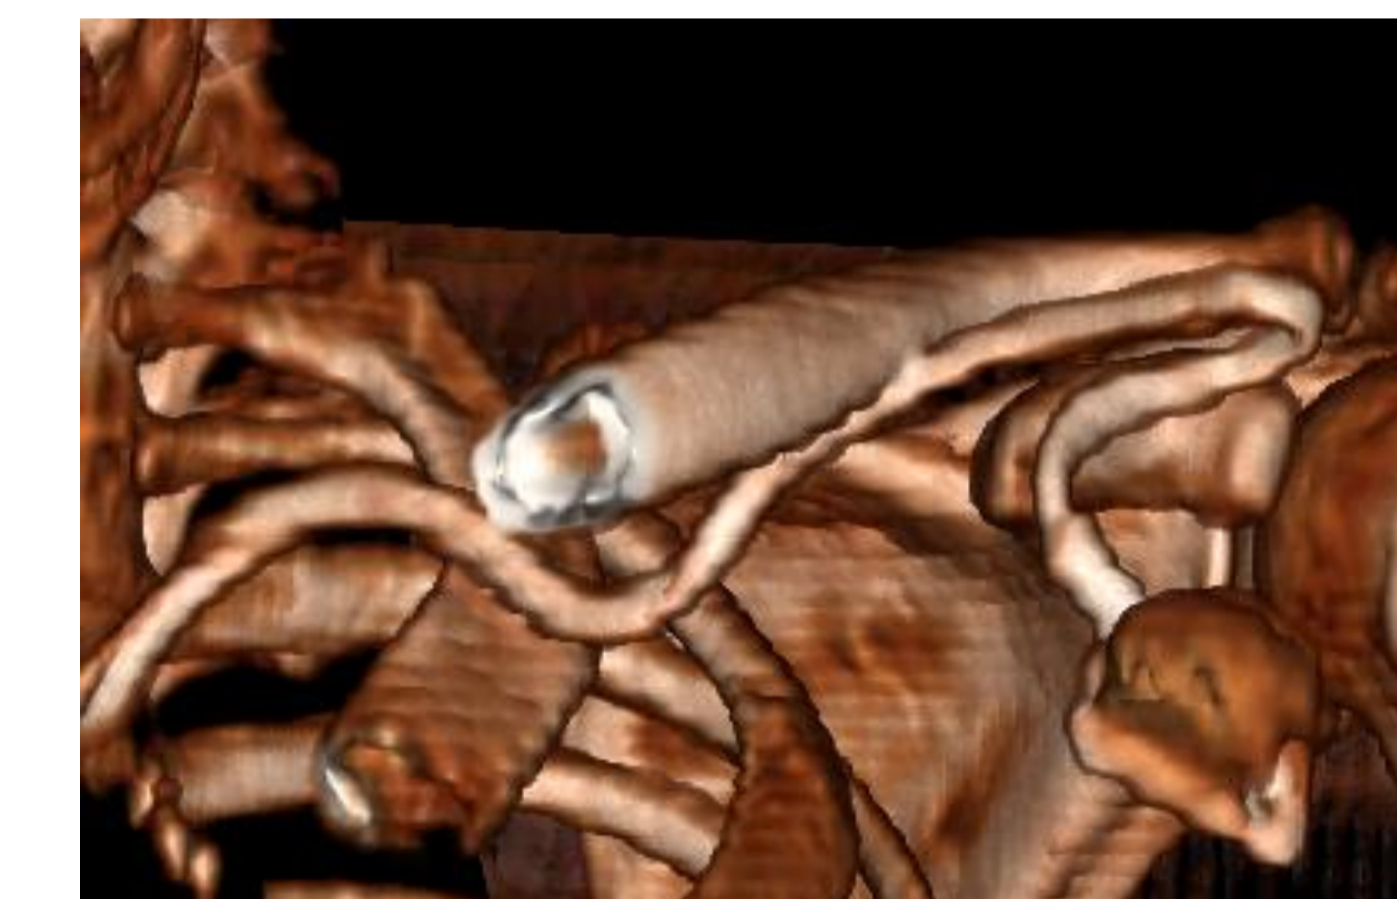
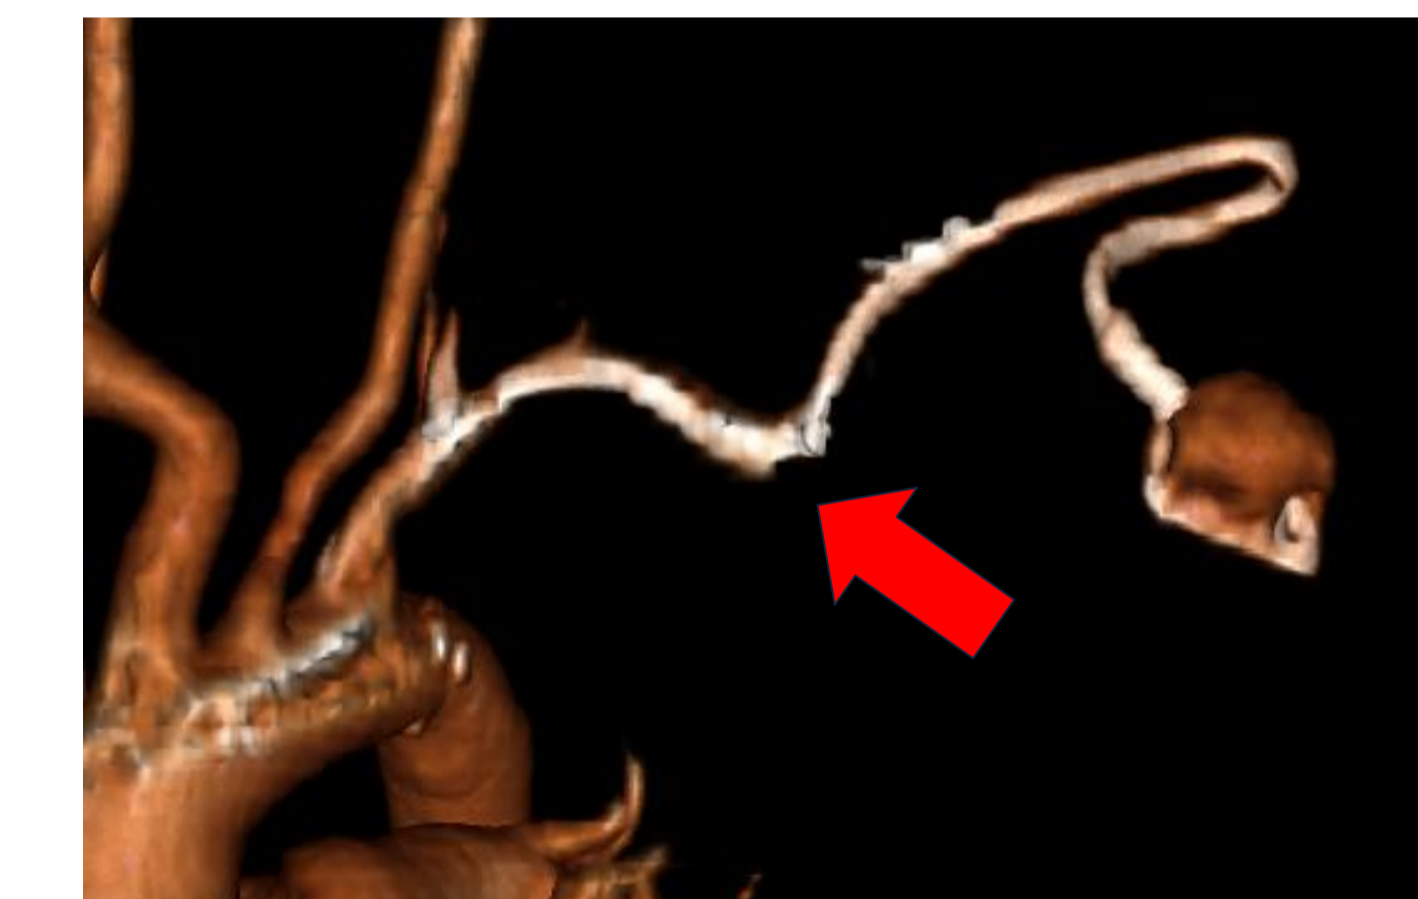
ANGIO-CT SCAN

ENTRY SITE IN THE SUBCLAVIAN ARTERY WITHOUT EVIDENCE OF ARTERIAL THROMBOSIS.

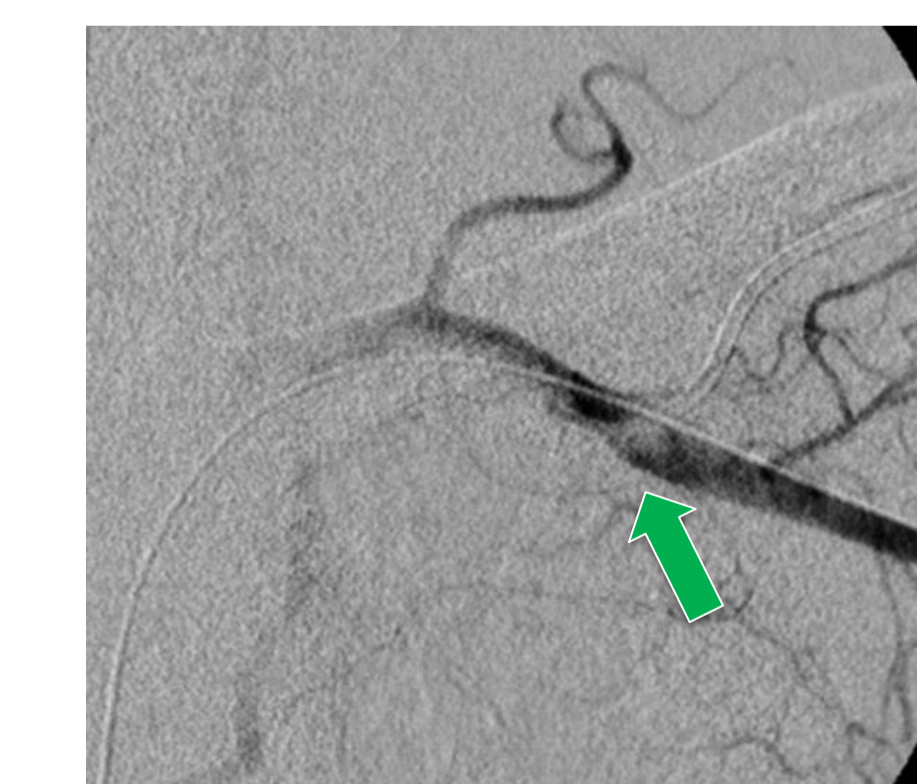
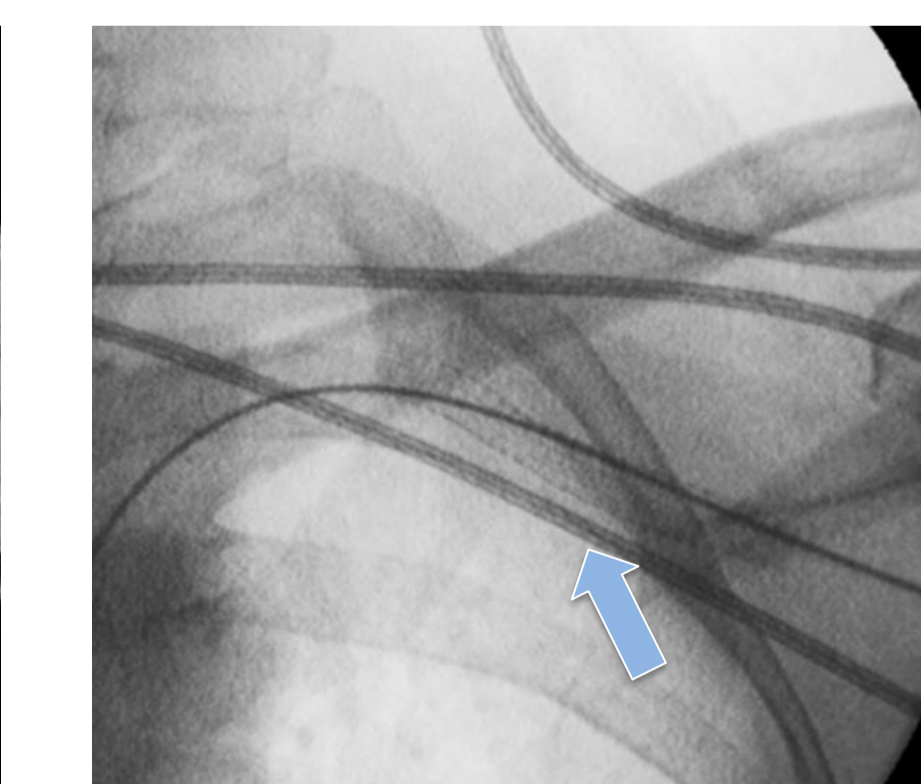
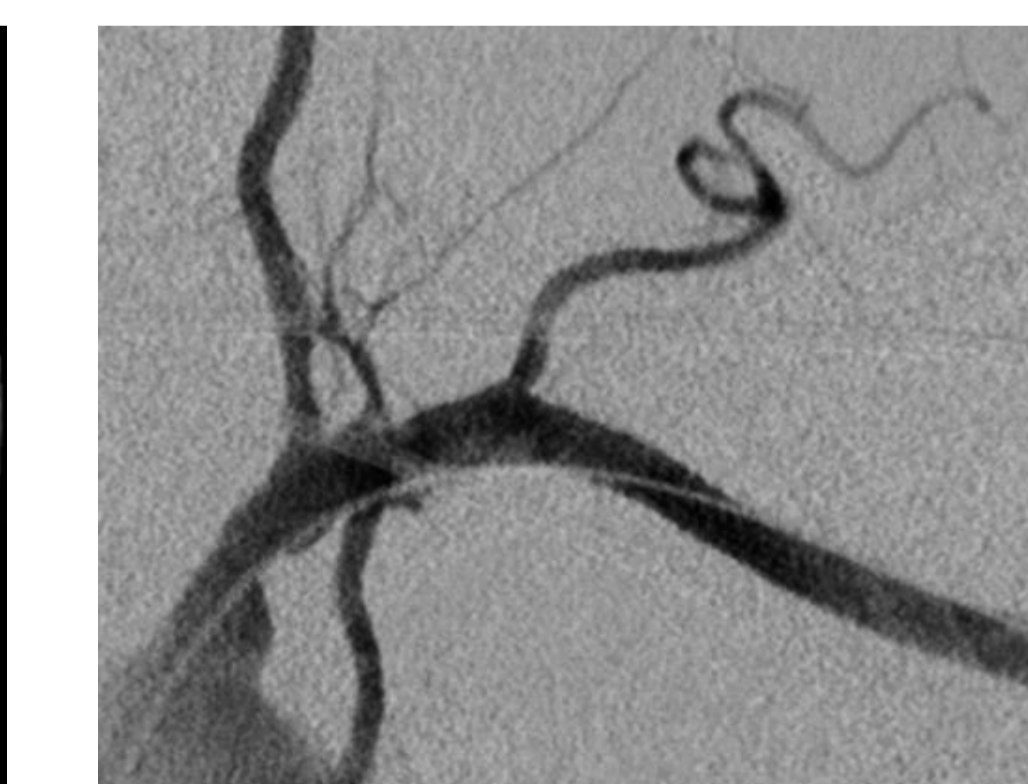
ENDOVASCULAR REPAIR with removal of the CVC and simultaneous release of a covered stent (Viabahn®).

The patient was discharged two days after surgery. **No complications** were reported during follow-up.
